**THE NATIONAL MARITIME MUSEUM ASSOCIATION**  
**Balclutha Deck Renewal Project**

**1997-1998  
Balclutha Deck Renewal Project**

**DAILY LOG**

**The present BALCLUTHA Main Deck Renewal Project**  
**began work in November of 1997 and lasted until June of 1998.**  
**The following photos and log are intended to chronicle the processes**  
**and results of this major restoration effort.**

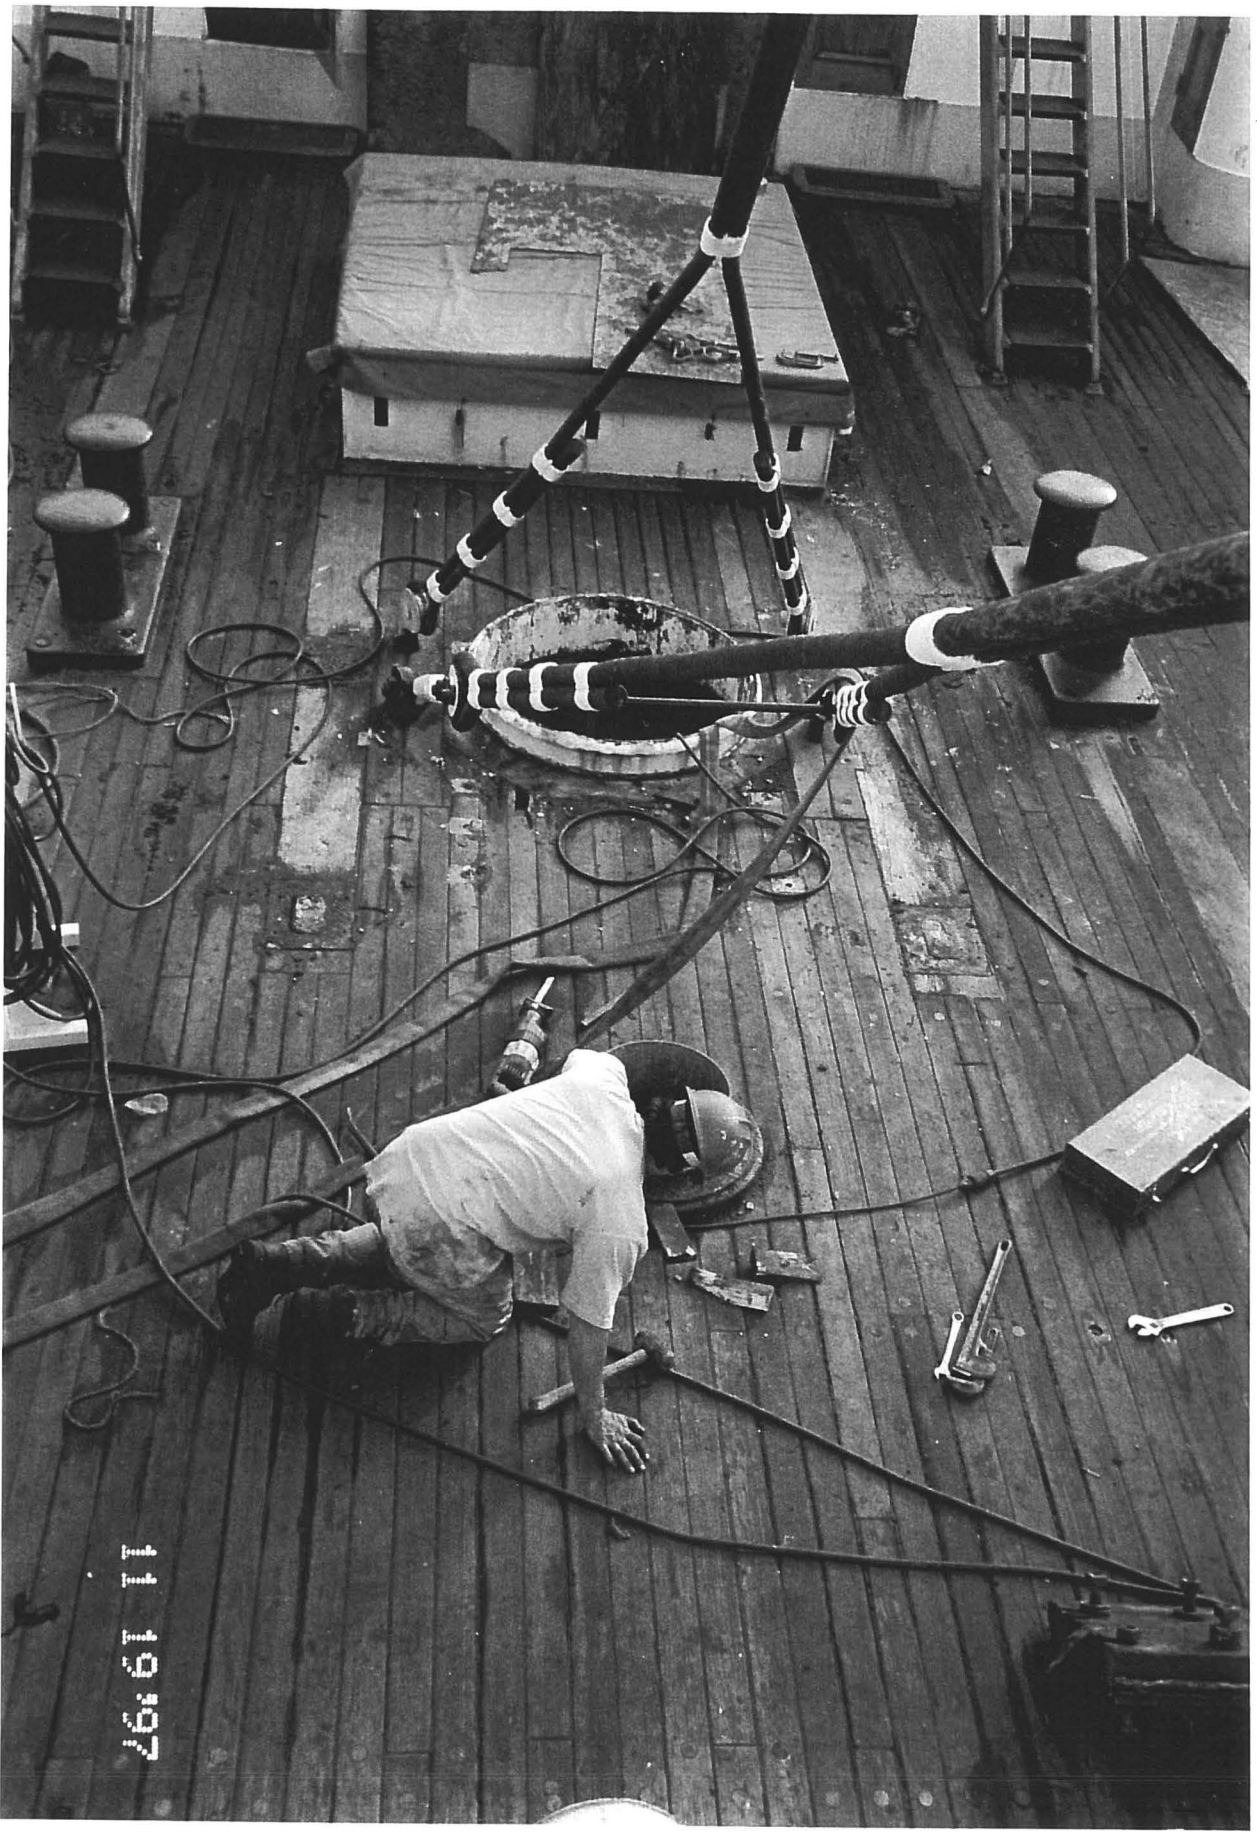
### **Rotten Fir Deck Planks.**

Much of the douglas fir deck planking removed was in good condition. Some of the rot pictured here was found around the main mast where the fresh water pump stood. One of the main goals of the Balclutha Deck Renewal Project was to restore the camber of the main deck designed originally to shed any standing water off the deck and down the waterways.

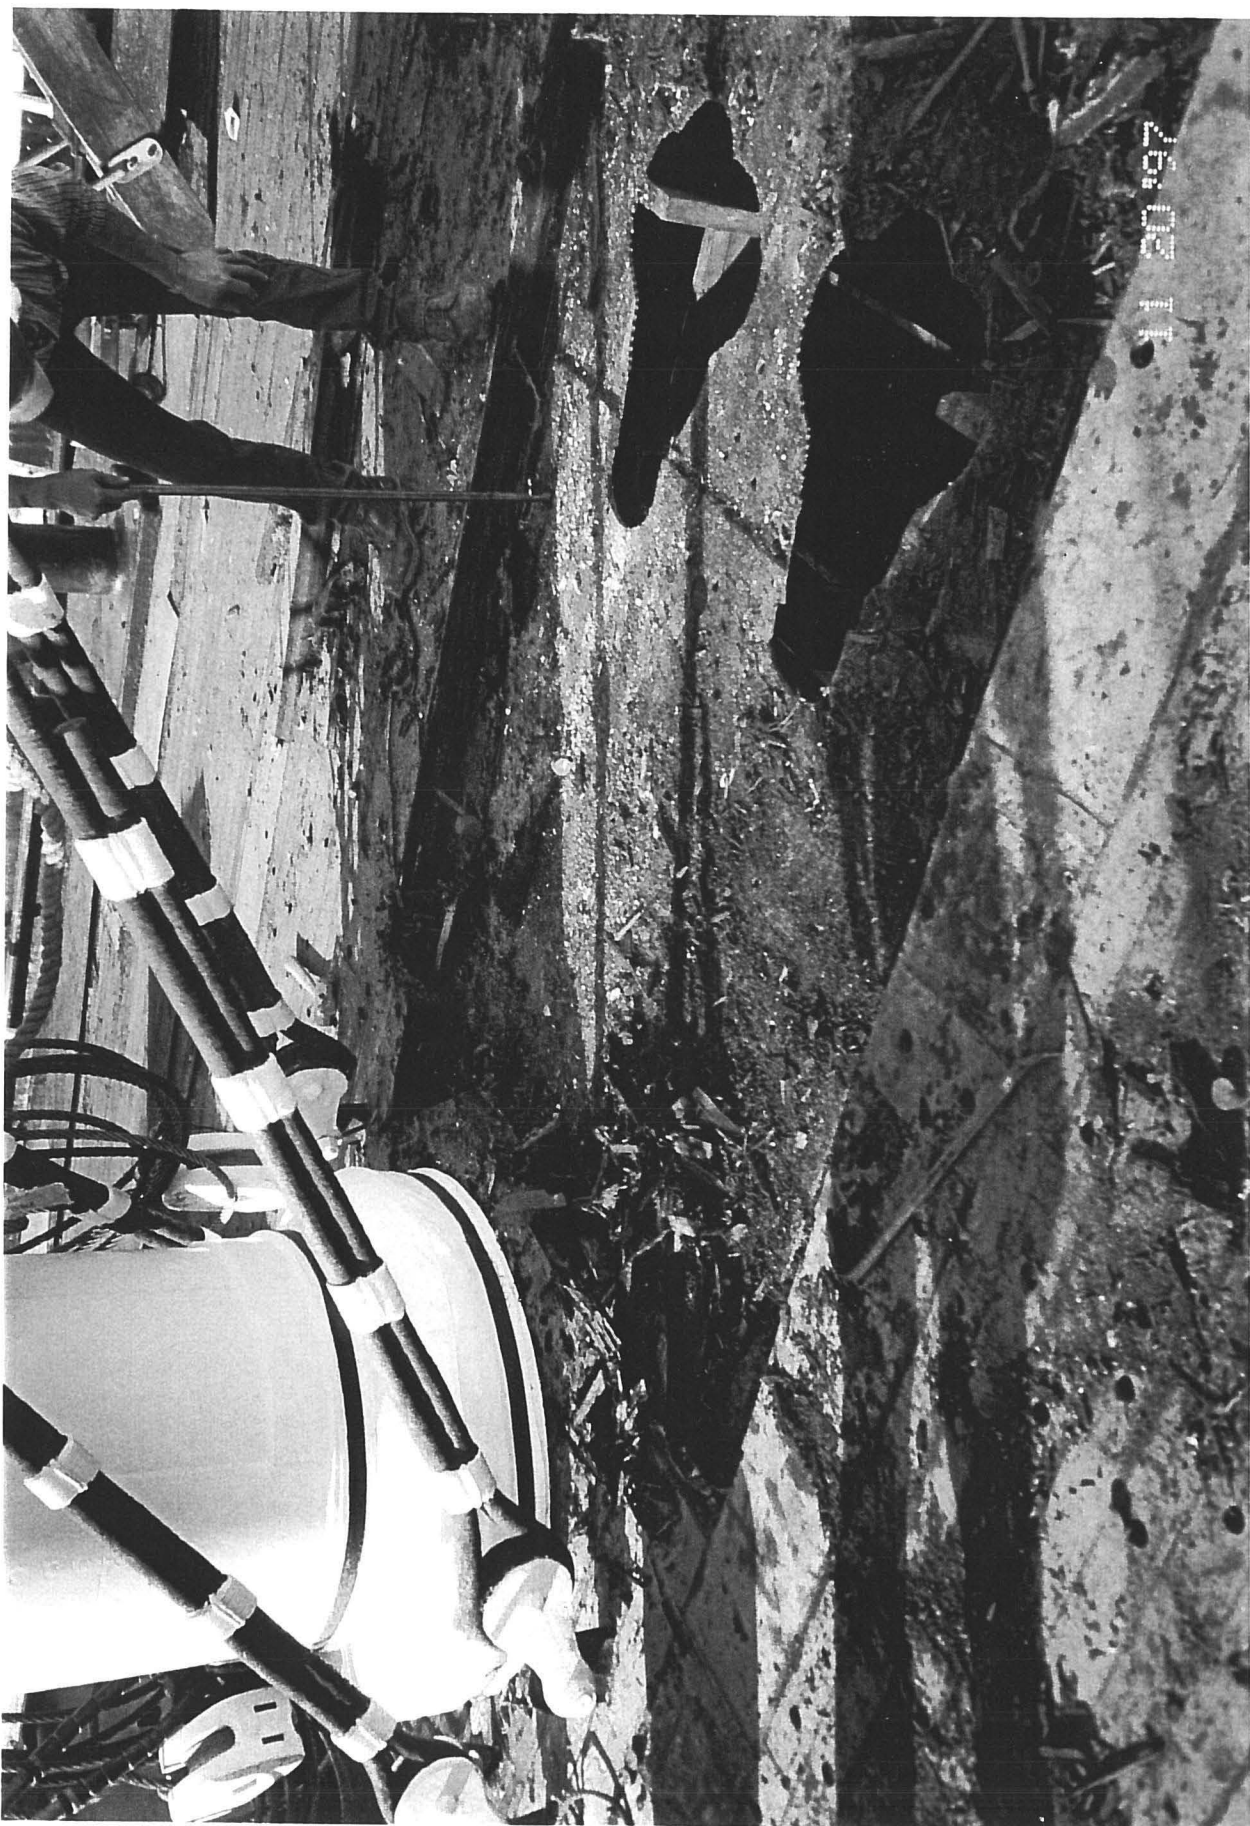
### **Rusted Steel Deck Plating.**

The steel structure underneath the main deck was affected by the rotten wood deck planking. The biggest uncertainty that faced the Balclutha Deck Renewal Project before the deck planking was removed was the condition of the steelwork and what repairs would be necessary. Corroded areas such as the one pictured here proved to be more dramatic than diagnostic as most of the underdeck steel work was found to be in salvageable condition.

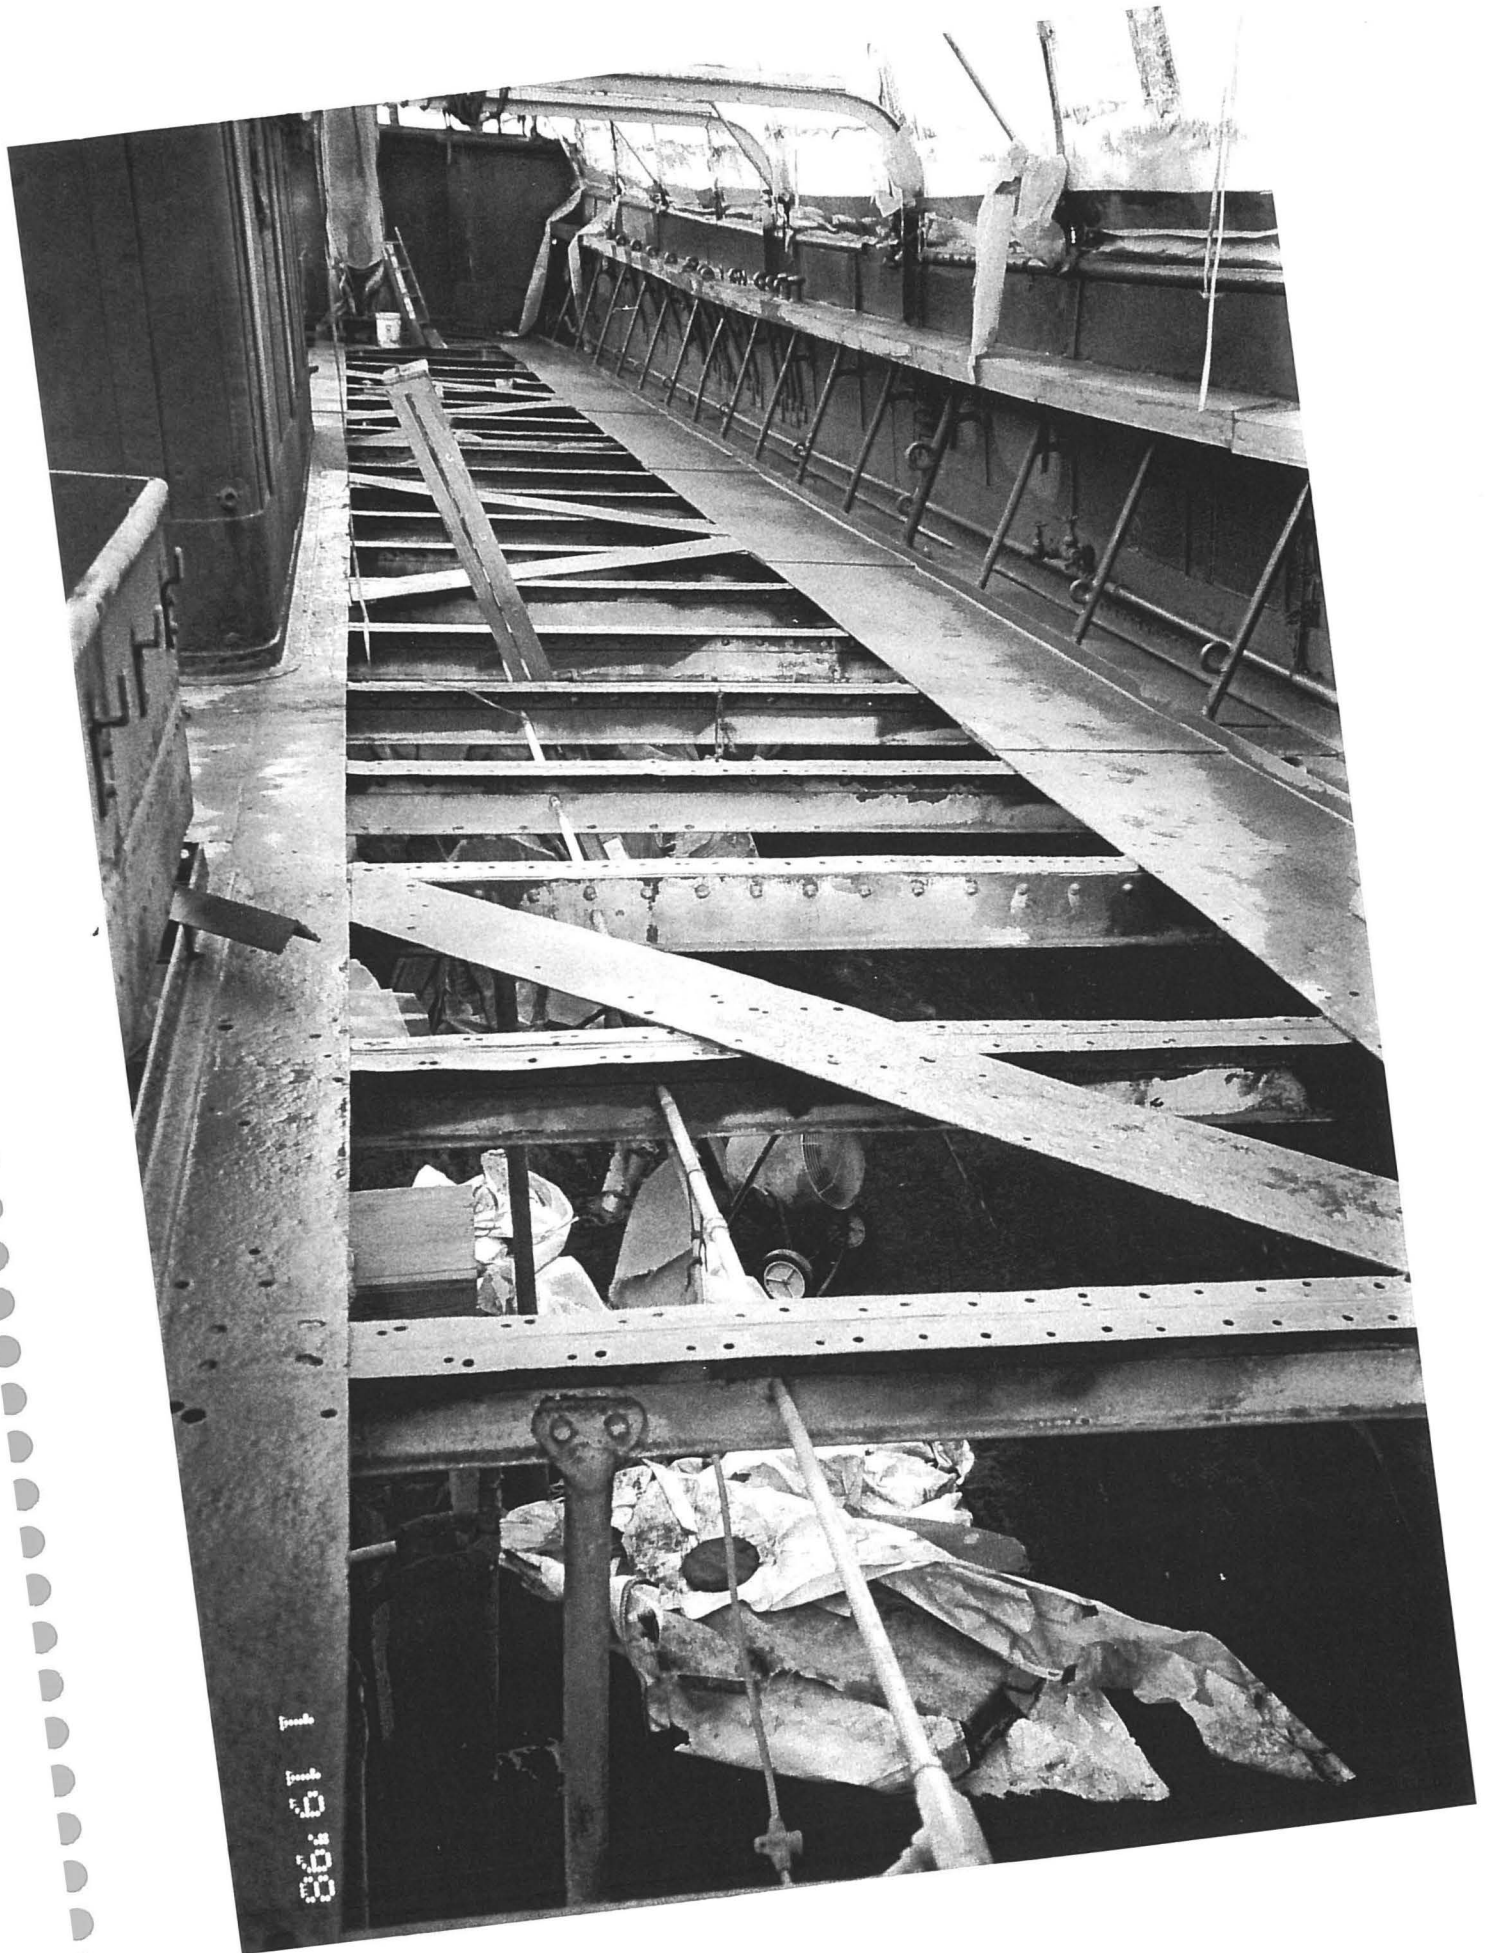
**Main Hatch Removed.**

The main hatch was completely disassembled, lifted out and placed on angle irons on the main deck. The necessary repairs were completed and each component was coated with two coats of epoxy primer before being lowered back into position and riveted together.

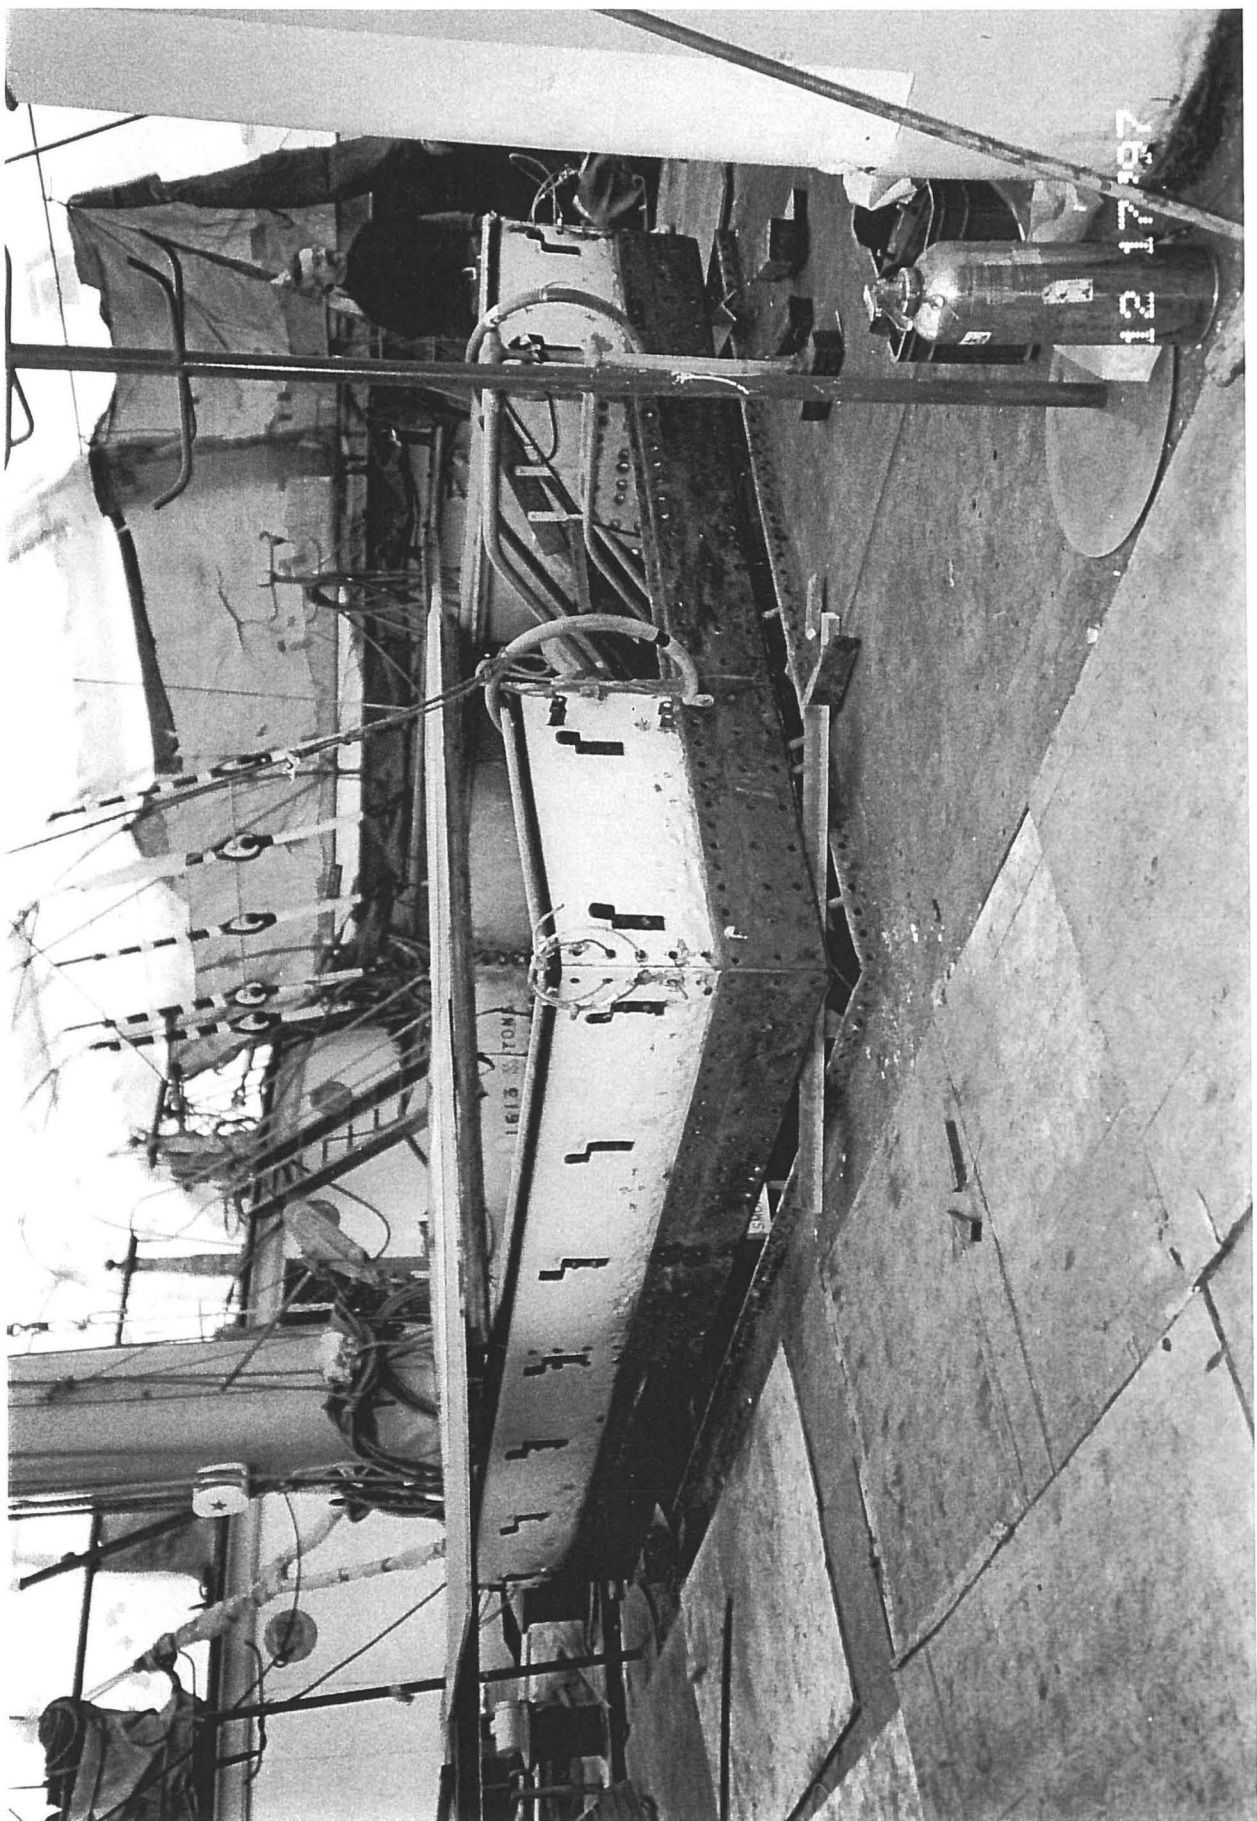
**Main Hatch Combing Corrosion.**

Layers of laminated steel were corroded away around the starboard side after end corner of the main hatch. After the entire main hatch was disassembled and lifted up on deck, the corroded area was marked off to be cut out with a torch and replaced with a new steel patch.

This afternoon three workers disassembled the sandblasting containment structure. Two welders cut out and replaced the corroded steel section at the starboard side after end corner of the main hatch.

At 2pm today, Bruce Vanvick from NPS said that the welds were cracking on the steel repair patch on the starboard side after end corner of the main hatch. Foreman Phil Lantz was alerted and the welder responsible was instructed to grind out the seams and re-weld.

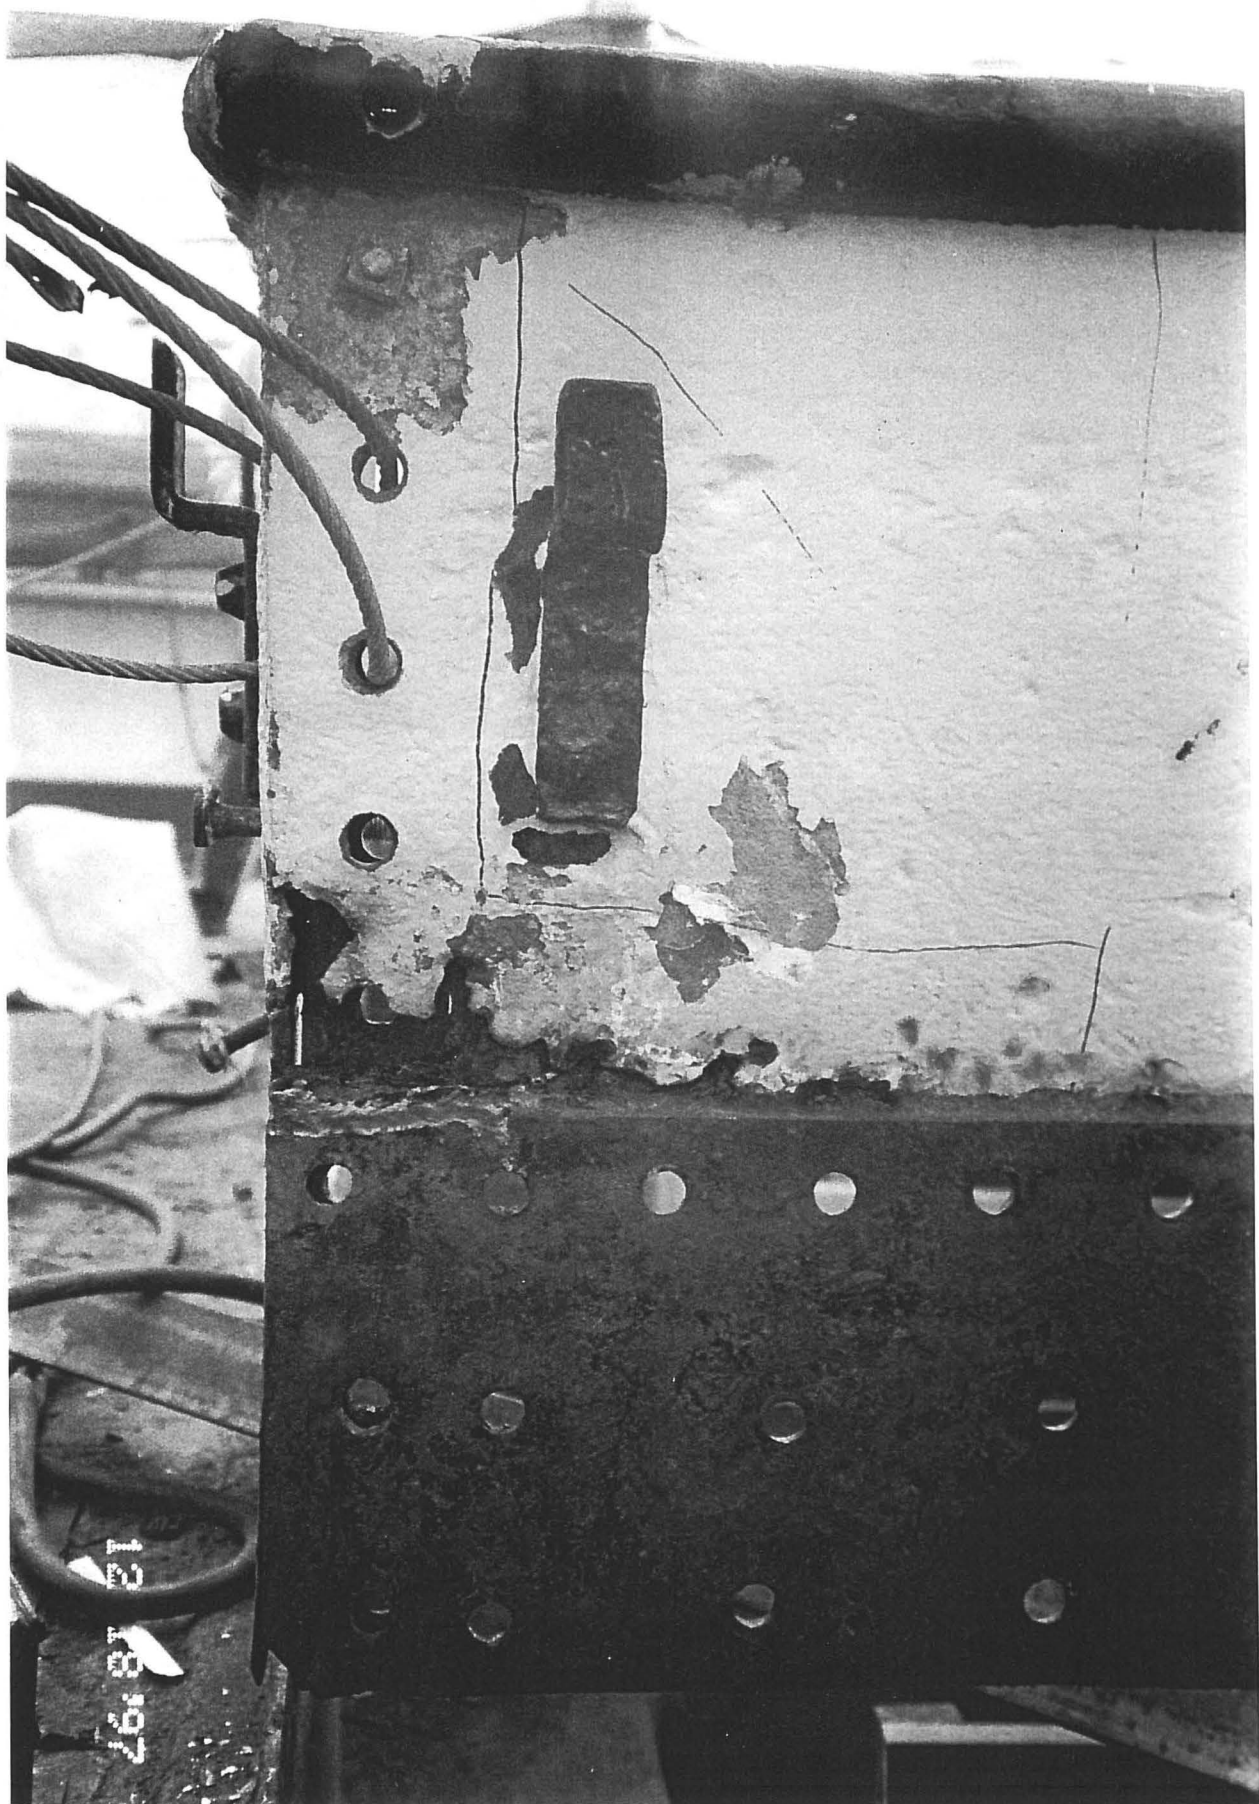
**Main Hatch Combing Repair Patch.**

A new steel plate was cut to fit where a corroded section was removed from the existing hatch combing. The insert pictured here was welded, faired in, painted and riveted to match the rest of the starboard side hatch combing.

This morning there were four workers cleaning up sand from sandblasting and disassembling the sandblasting containment structure. One welder was finishing and painting over the steel repair patch at the starboard side after end corner of the main hatch. Two welders were working on repairs to the deck beams around the forward hatch. This afternoon there were three welders working on the steel repairs to the deck beams around the forward hatch and four workers cleaning up sand from sandblasting and painting steel at the tween decks.

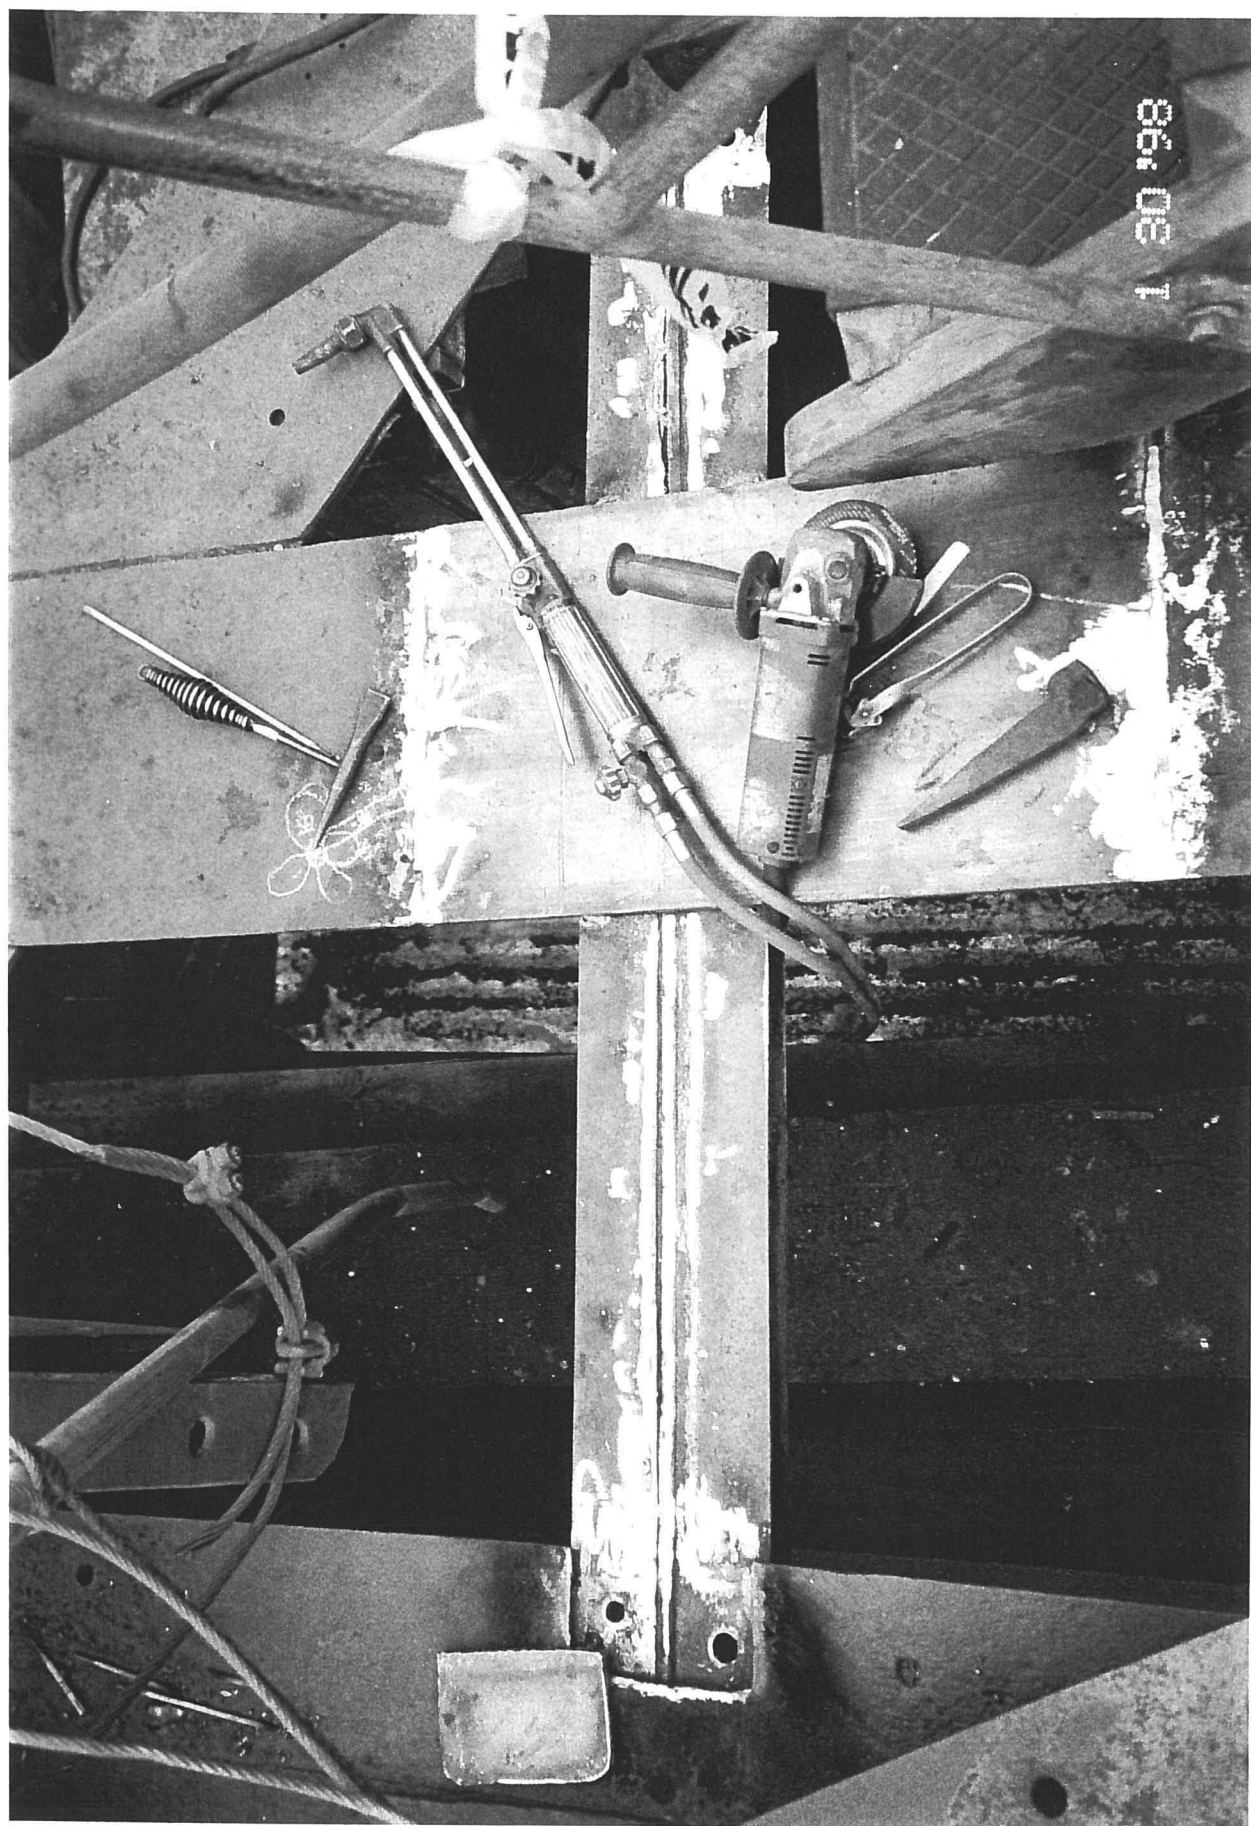
**Steel Deck Beam Repairs.**

Sections of deck beam flange and margin plate have been replaced with new steel. This photo shows new steel sections fastened around the port side of the forward hatch before being riveted together and before any deck bolt holes were drilled.

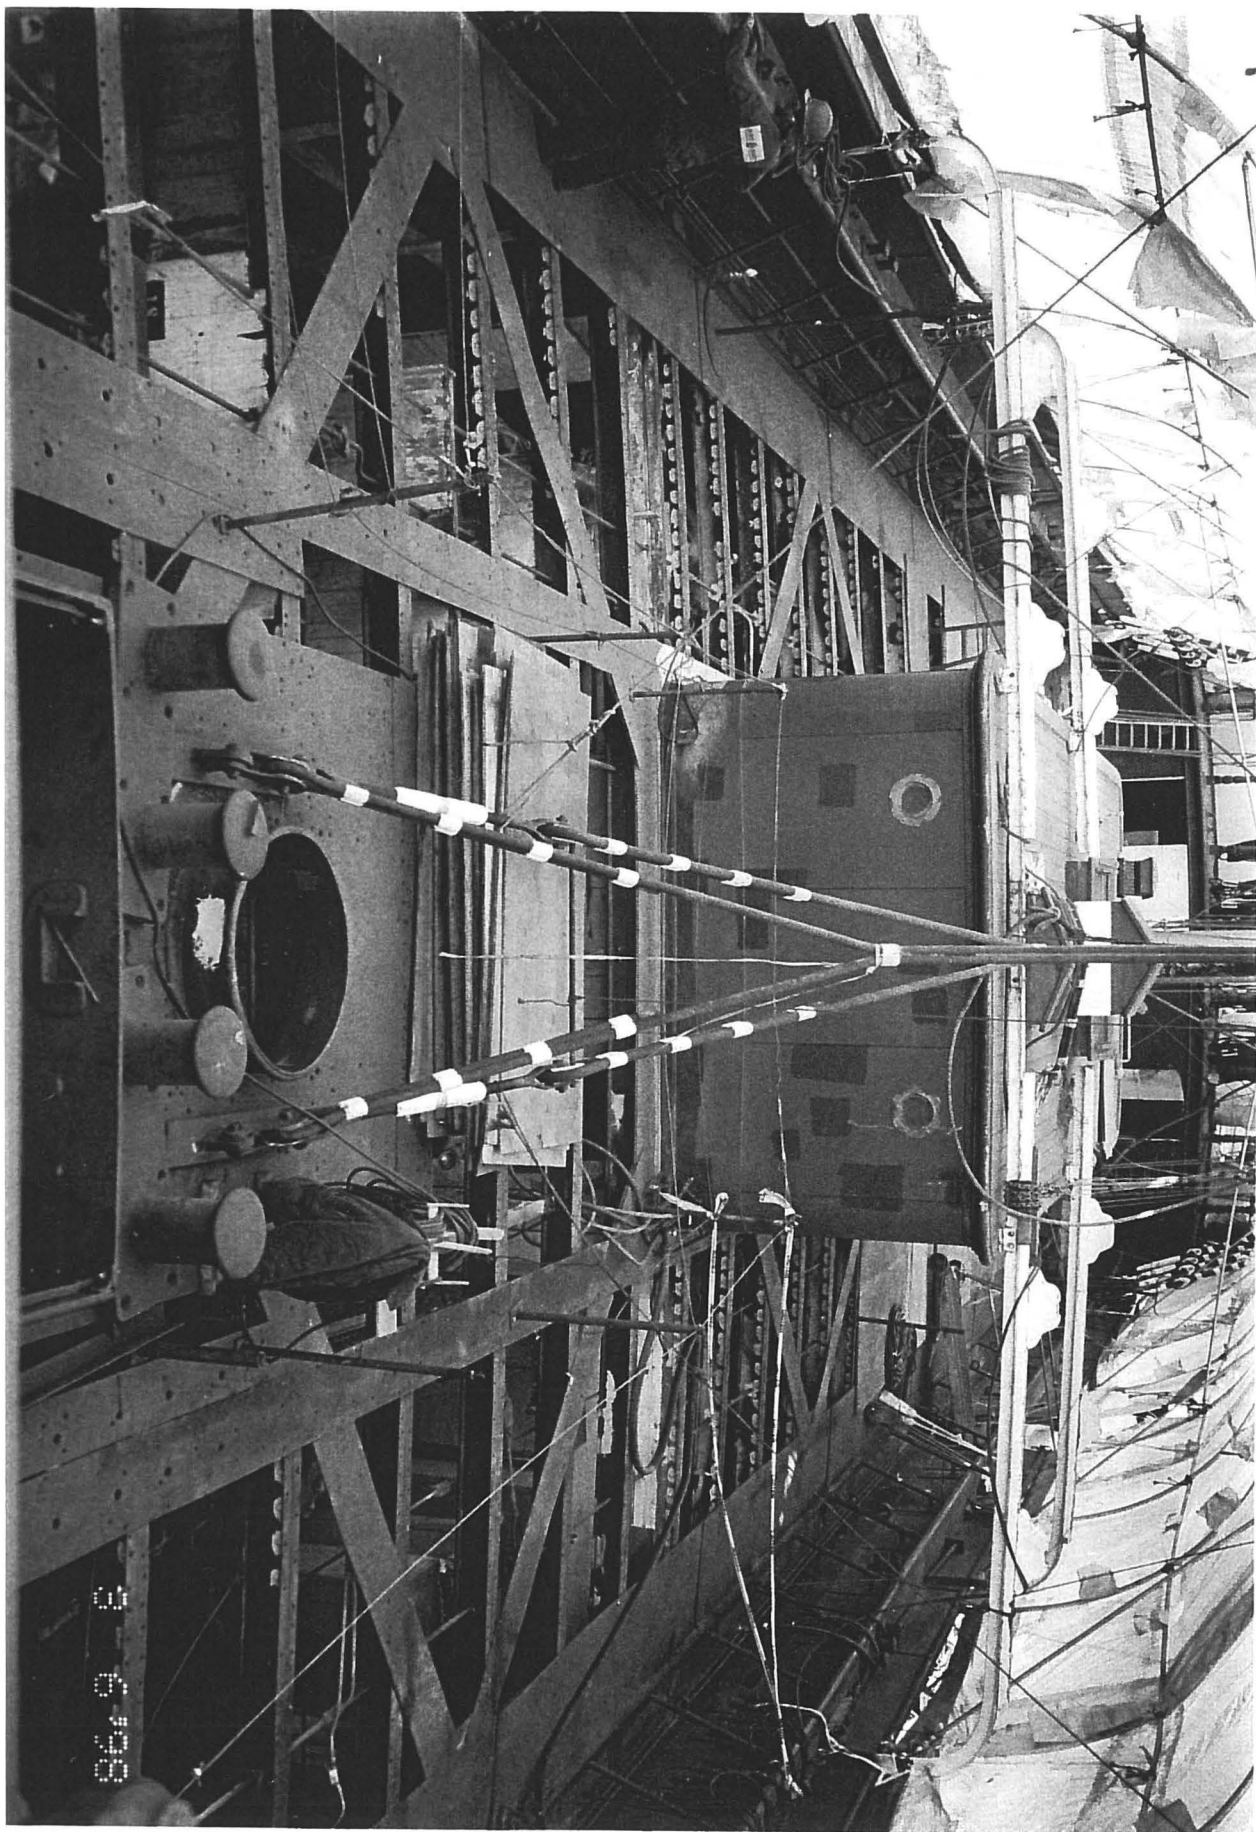
### **Forward Hatch Repair.**

Three sides of the forward hatch were completely disassembled to facilitate the necessary repairs. Most of the hundreds of original rivets that held the hatch combings together were found to be still binding the steel plates together with strong and watertight joints.

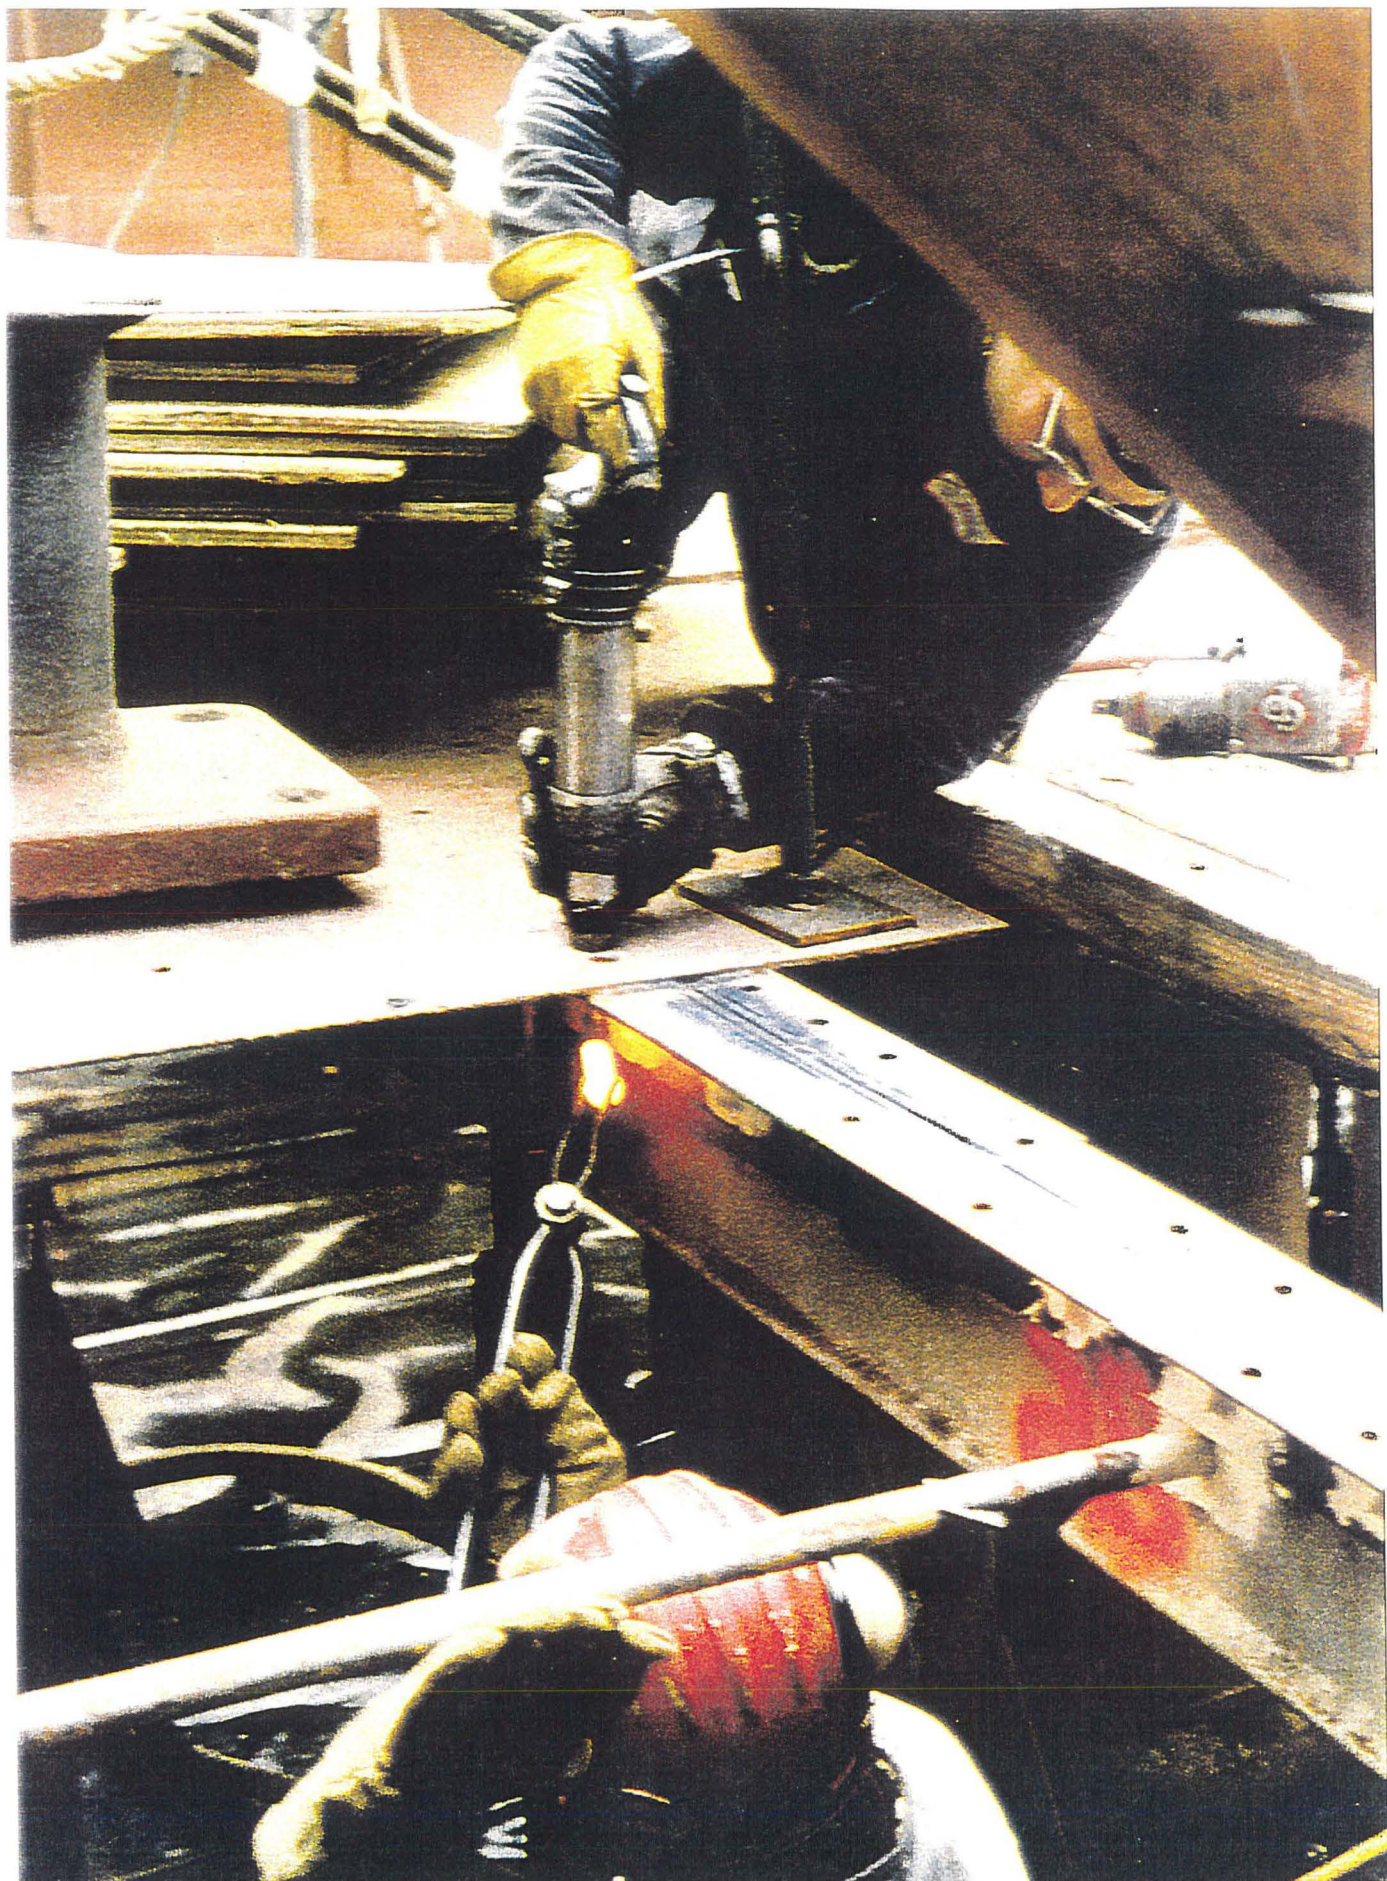
**The BALCLUTHA in Drydock.**

The 111 year old ship was hauled out for the first time since 1986. The hull below the waterline was found to be in remarkably good condition. The entire hull was sandblasted, the necessary steel repairs were carried out, new zinc plates were installed and the ship was coated with anti-corrosive epoxy paints.
